**Flood Control Project Maintenance
Levee Inspections**
LMA District Cover Sheet
Spring 2017 Levee Inspection Results

Lake County Watershed Protection District

Spring 2017 Levee Inspection Results

Waterway			Bank	Unit Miles
Unit No. 01 Middle Creek			Left	3.35
	Spring (March - May)	Summer (June - August)	(September - November) Fall	Winter (December - February)
Unit Maintenance Rating (Fall Only)				
Date of Inspection	4/4/2017 - 4/4/2017			
DWR Inspector	Bob Duffey			
Accompanied By	Will Evans Lake County

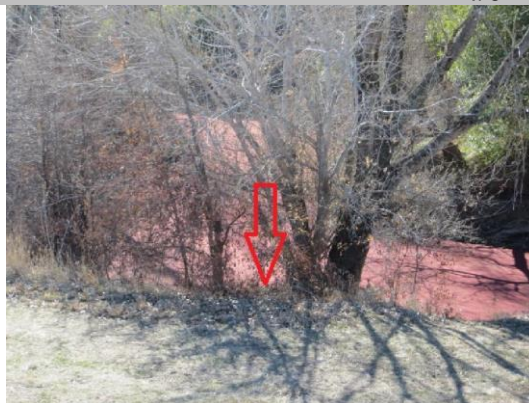
Photo 1 of 3 : UCIP_SP_2017_27894_51599.jpg

LM Start	0.93	Rating **	M	Issue No.	25
LM End	0.93	Issue Type +	Ma	Location *	WS
Category	Supplemental			GPS Latitude/Longitude	
				Start	End
Item	DWR UCIP LMA Responsibility			39.159736 °	39.159736 °
				-122.921042 °	-122.921042 °
DWR ID					
Comment Code					
Inspector Comment					
FS_ID:27894 DS_ID:21221 EP_NO: 11488 Repair Type: Non-Urgent Crossing Status: Found UCIP Comments: Concrete headwall on WS berm is being undermined. 2-foot of scour under headwall. FIELD_STRUCT_DESC: 42-inch CM drainpipe through the levee, 16.5 feet below the crown. Flap gate on the waterward end. Concrete headwalls on both ends. (USACE-1961). This entry matches the Drainage or Irrigation Structure referenced in O&M manual (HLM 0.94). This pipe was retained under ABO No. 11488 (1975). FS Date: 1/22/2014

Flapgate and headwall off WS toe.

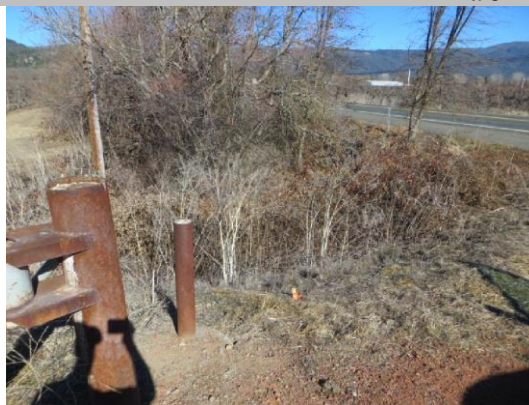
Photo 2 of 3 : UCIP_SP_2017_27894_51598.jpg

Concrete headwall on LS toe.

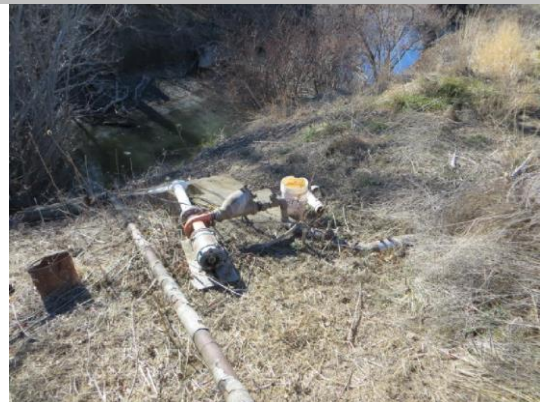
Photo 1 of 3 : UCIP_SP_2017_27903_51622.jpg

Comment Code					
Inspector Comment					
FS_ID:27903 DS_ID:21248 EP_NO: 11488 Repair Type: Non-Urgent Crossing Status: Indicator Found UCIP Comments: Siphon breaker standpipe knocked over and covered with dirt. Pipe and appurtances appear to be in disrepair. Gate valves next to tank broken. FIELD_STRUCT_DESC: 6-inch steel irrigation pipe through the levee, 2.5 feet below the crown. Siphon breaker in 24-cmp riser on LS shoulder. Screw gate on waterside slope next to pump and 300-gallon tank. (USACE-1961). This entry matches the Drainage or Irrigation Structure referenced in O&M manual (HLM 1.02). This pipe was retained under ABO No. 11488 (1975). FS Date: 1/22/2014

Pump at concrete pad on WS berm.

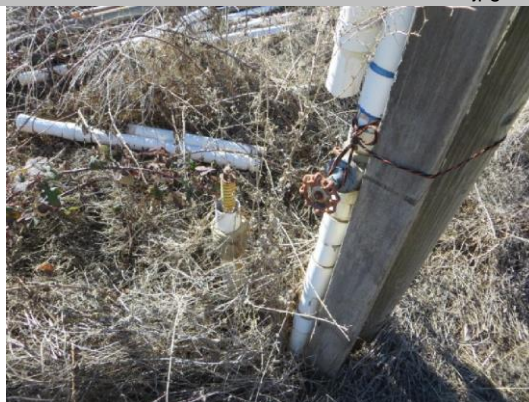
Photo 3 of 3 : UCIP_SP_2017_27903_51620.jpg

Comment Code						
Inspector Comment						
FS_ID:27903 DS_ID:21248 EP_NO: 11488 Repair Type: Non-Urgent Crossing Status: Indicator Found UCIP Comments: Siphon breaker standpipe knocked over and covered with dirt. Pipe and appurtances appear to be in disrepair. Gate valves next to tank broken. FIELD_STRUCT_DESC: 6-inch steel irrigation pipe through the levee, 2.5 feet below the crown. Siphon breaker in 24-cmp riser on LS shoulder. Screw gate on waterside slope next to pump and 300-gallon tank. (USACE-1961). This entry matches the Drainage or Irrigation Structure referenced in O&M manual (HLM 1.02). This pipe was retained under ABO No. 11488 (1975). FS Date: 1/22/2014

filler valves on LS toe.

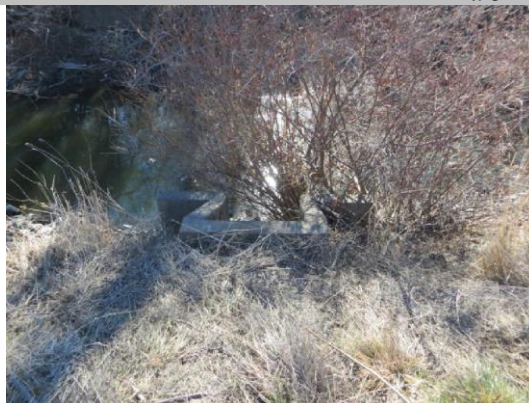
Photo 1 of 3 : UCIP_SP_2017_27943_51642.jpg

LM Start	0.99	Rating **	M	Issue No.	27
LM End	0.99	Issue Type +	Ma	Location *	WS
Category	Supplemental			GPS Latitude/Longitude	
				Start	End
Item	DWR UCIP LMA Responsibility			39.160117°	39.160117°
				-122.922144°	-122.922144°
DWR ID					
Comment Code					
Inspector Comment					
FS_ID:27943					
DS_ID:21222					
EP_NO: 11488					
Repair Type: Non-Urgent					
Crossing Status: Found					
UCIP Comments: Some vegetation buildup at inlet and outlet.					
FIELD_STRUCT_DESC: 24-inch CM drainpipe through the levee, 14.0 feet below the crown. Flap gate on the waterward end. Concrete headwalls on both ends. (USACE-1961). This entry matches the Drainage or Irrigation Structure referenced in O&M manual (HLM 1.01). This pipe was retained under ABO No. 11488 (1975).					
FS Date: 1/22/2014

Concrete Headwall on WS berm.

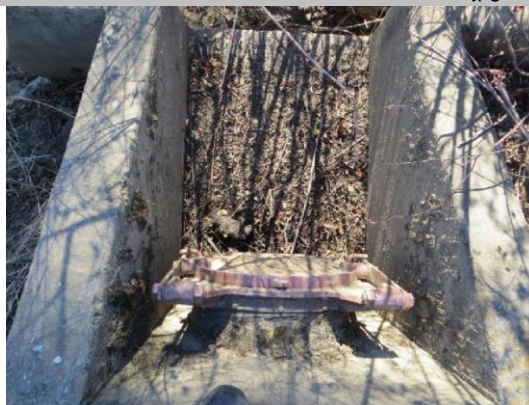
Photo 2 of 3 : UCIP_SP_2017_27943_51641.jpg

Headwall and flapgate on WS berm.

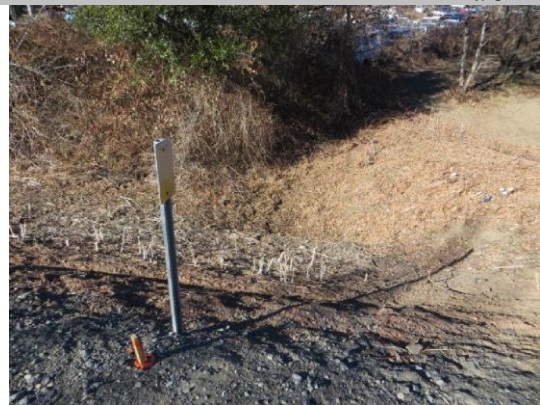
Photo 1 of 3 : UCIP_SP_2017_27944_51646.jpg

LM Start	1.07	Rating **	M	Issue No.	28
LM End	1.07	Issue Type +	Ma	Location *	WS
Category	Supplemental			GPS Latitude/Longitude	
				Start	End
Item	DWR UCIP LMA Responsibility			39.159803 °	39.159803 °
				-122.923501 °	-122.923501 °
DWR ID					
Comment Code					
Inspector Comment					
FS_ID:27944 DS_ID:21223 EP_NO: 11489 Repair Type: Non-Urgent Crossing Status: Found UCIP Comments: Some sedimentation buildup at inlet and through pipe. FIELD_STRUCT_DESC: 24-inch CM drainpipe through the levee, 12.5 feet below the crown. Flap gate on the waterward end. Concrete headwalls on both ends. (USACE-1961). This entry matches the Drainage or Irrigation Structure referenced in O&M manual (HLM 1.09). This pipe was retained under ABO No. 11489 (1975). FS Date: 1/22/2014

Flasher on crown marks pipe location.

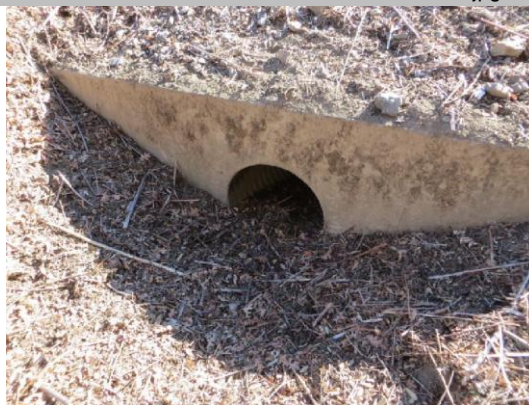
Photo 3 of 3 : UCIP_SP_2017_27944_51644.jpg

Concrete headwall on LS toe.

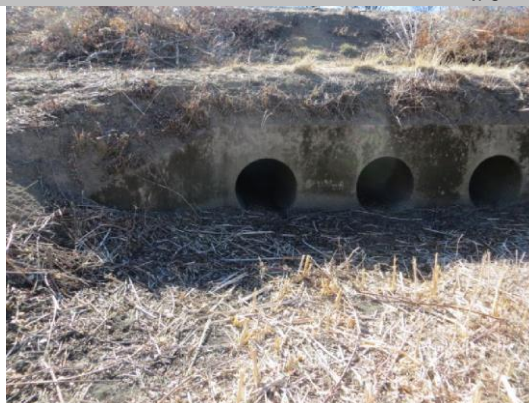
Photo 1 of 3 : UCIP_SP_2017_27963_51662.jpg

LM Start	1.23	Rating **	A/W	Issue No.	29
LM End	1.23	Issue Type +	Ma	Location *	LS
Category	Supplemental			GPS Latitude/Longitude	
				Start	End
Item	DWR UCIP LMA Responsibility			39.160359 °	39.160359 °
				-122.926188 °	-122.926188 °
DWR ID					
Comment Code					
Inspector Comment					
FS_ID:27963					
DS_ID:21224					
EP_NO: 11489					
Repair Type: No Action Needed					
Crossing Status: Found					
UCIP Comments:					
FIELD_STRUCT_DESC: 1 of 4: 36-inch CM drainpipe through the					
levee, 15.2 feet below the crown. Flap gate on the waterward end.					
Concrete headwalls on both ends. (USACE-1961). This entry matches					
the Drainage or Irrigation Structure referenced in O&M manual (HLM					
1.25). This pipe was retained under ABO No. 11489 (1975).					
FS Date: 1/22/2014

Concrete headwall on LS toe.

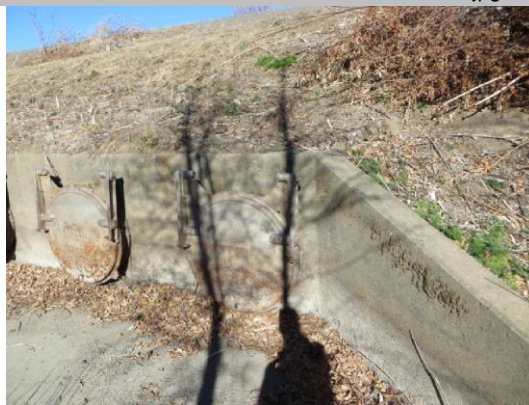
Photo 3 of 3 : UCIP_SP_2017_27963_51660.jpg

Flapgate on headwall at WS toe.

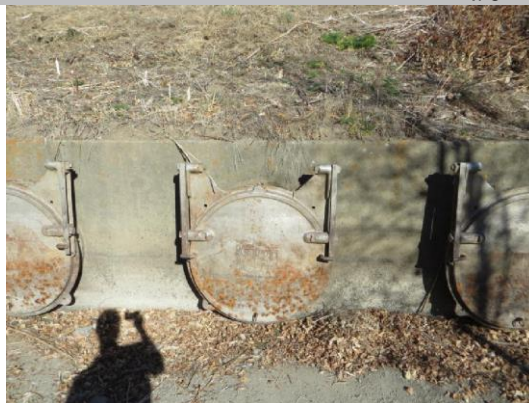
Photo 3 of 3 : UCIP_SP_2017_27964_51663.jpg

LM Start	1.23	Rating **	A/W	Issue No.	30 (cont)
LM End	1.23	Issue Type +	Ma	Location *	LS
Category	Supplemental			GPS Latitude/Longitude	
				Start	End
Item	DWR UCIP LMA Responsibility			39.160369 °	39.160369 °
				-122.926208 °	-122.926208 °
DWR ID					
Comment Code					
Inspector Comment					
FS_ID:27964 DS_ID:21237 EP_NO: 11489 Repair Type: No Action Needed Crossing Status: Found UCIP Comments: FIELD_STRUCT_DESC: 2 of 4: 36-inch CM drainpipe through the levee, 15.2 feet below the crown. Flap gate on the waterward end. Concrete headwalls on both ends. (USACE-1961). This entry matches the Drainage or Irrigation Structure referenced in O&M manual (HLM 1.25). This pipe was retained under ABO No. 11489 (1975). FS Date: 1/22/2014

Flapgate and headwall on WS toe.

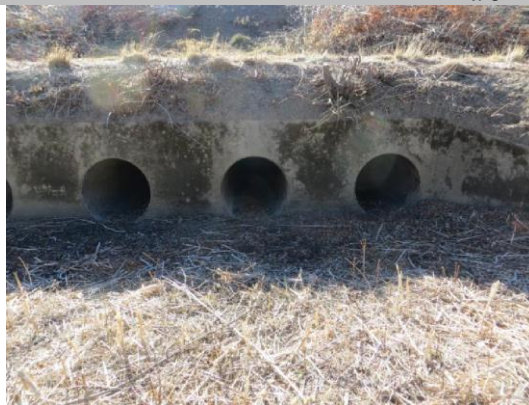
Photo 1 of 3 : UCIP_SP_2017_27965_51668.jpg

LM Start	1.24	Rating **	A/W	Issue No.	31
LM End	1.24	Issue Type +	Ma	Location *	LS
Category	Supplemental			GPS Latitude/Longitude	
				Start	End
Item	DWR UCIP LMA Responsibility			39.160377 °	39.160377 °
				-122.926223 °	-122.926223 °
DWR ID					
Comment Code					
Inspector Comment					
FS_ID:27965					
DS_ID:21238					
EP_NO: 11489					
Repair Type: No Action Needed					
Crossing Status: Found					
UCIP Comments:					
FIELD_STRUCT_DESC: 3 of 4: 36-inch CM drainpipe through the					
levee, 15.2 feet below the crown. Flap gate on the waterward end.					
Concrete headwalls on both ends. (USACE-1961). This entry matches					
the Drainage or Irrigation Structure referenced in O&M manual (HLM					
1.25). This pipe was retained under ABO No. 11489 (1975).					
FS Date: 1/22/2014

Pipe and concrete headwall on LS toe.

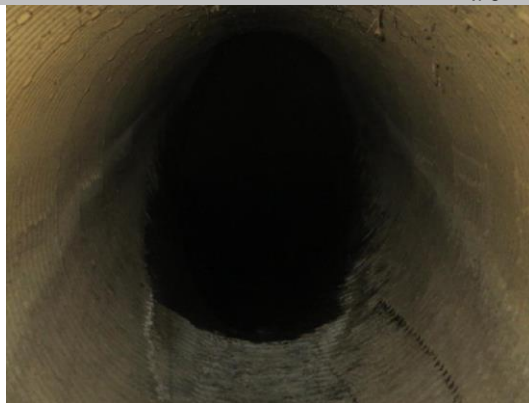
Photo 2 of 3 : UCIP_SP_2017_27965_51667.jpg

Pipe from LS toe.

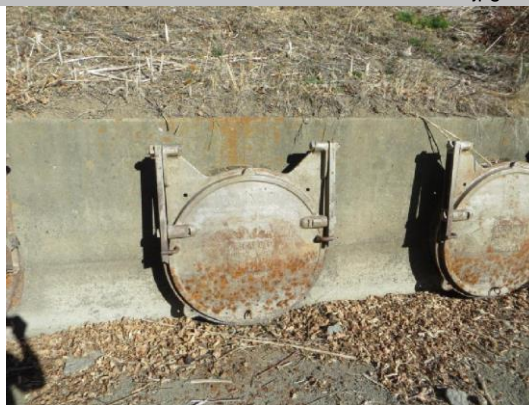
Photo 3 of 3 : UCIP_SP_2017_27965_51666.jpg

Flapgate on headwall at WS toe.

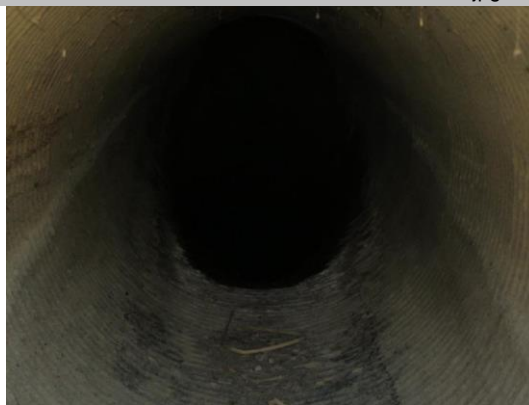
Photo 2 of 3 : UCIP_SP_2017_27967_51670.jpg

Pipe from LS toe.

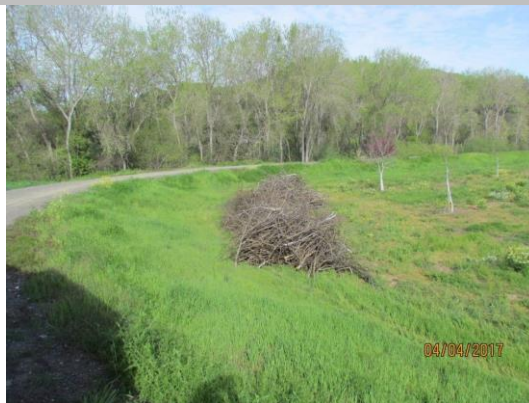
Photo 1 of 1 : SP_2017_NA0009_6_16_20170410_00022.jpg

LM Start	0.01	Rating **	M	Issue No.	16
LM End	0.01	Issue Type +	En	Location *	LS
Category	Earthen Levee			GPS Latitude/Longitude	
				Start	End
Item	Encroachments			39.176193 °	39.176193 °
				-122.912307 °	-122.912307 °
DWR ID	DWR_NA0009_04_s_2017_16				
Comment Code					
PR : Prunings					
Inspector Comment					
Remove the prunings from the landside toe.

View of the prunings along the landside toe.

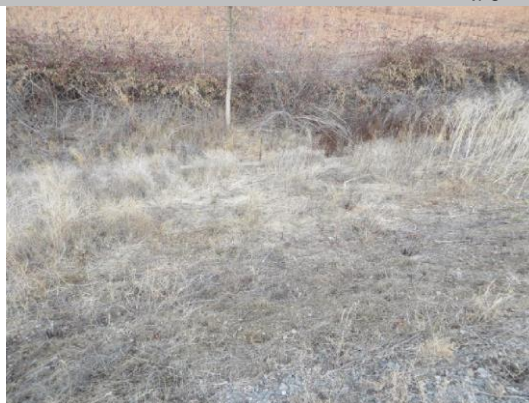
Photo 1 of 3 : UCIP_SP_2017_26947_49793.jpg

LM Start	0.14	Rating **	A/W	Issue No.	17
LM End	0.14	Issue Type +	Ma	Location *	LS
Category	Supplemental			GPS Latitude/Longitude	
				Start	End
Item	DWR UCIP LMA Responsibility			39.176422 °	39.176422 °
				-122.909978 °	-122.909978 °
DWR ID					
Comment Code					
Inspector Comment					
FS_ID:26947 DS_ID:21236 EP_NO: 11499 Repair Type: No Action Needed Crossing Status: Found UCIP Comments: FIELD_STRUCT_DESC: 1 of 2: 42-inch CM drainpipe through the levee, 12.0 feet below the crown. Flap gate on the waterward end. Concrete headwalls on both ends. Originally included in 1961 O+M manual. Retained under ABO No. 11499 (1975). FS Date: 1/9/2014

Concrete headwall visible on LS toe.

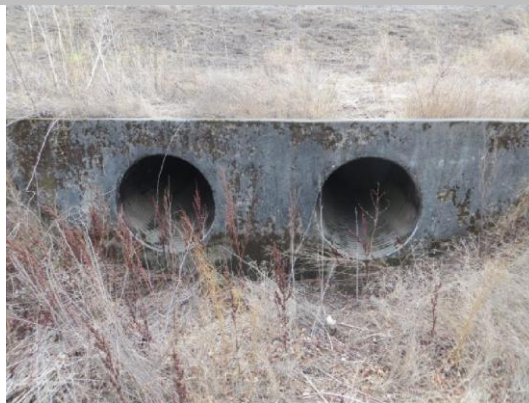
Photo 2 of 3 : UCIP_SP_2017_26948_49796.jpg

Concrete headwall and inlet visible on LS toe.

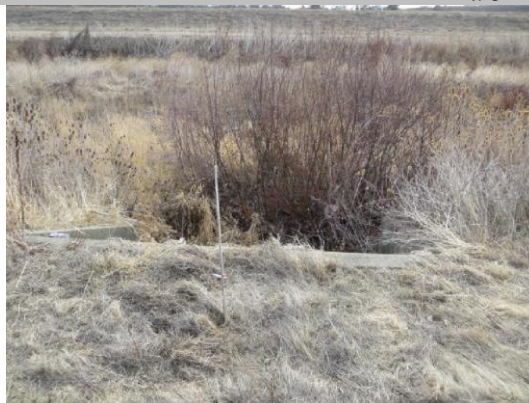
Photo 3 of 3 : UCIP_SP_2017_26948_49795.jpg

LM Start	0.14	Rating **	A/W	Issue No.	18 (cont)
LM End	0.14	Issue Type +	Ma	Location *	LS
Category	Supplemental			GPS Latitude/Longitude	
				Start	End
Item	DWR UCIP LMA Responsibility			39.176419 °	39.176419 °
				-122.909954 °	-122.909954 °
DWR ID					
Comment Code					
Inspector Comment					
FS_ID:26948					
DS_ID:21225					
EP_NO: 11499					
Repair Type: No Action Needed					
Crossing Status: Found					
UCIP Comments:					
FIELD_STRUCT_DESC: 2 of 2: 42-inch CM drainpipe through the					
levee, 12.0 feet below the crown. Flap gate on the waterward end.					
Concrete headwalls on both ends. Originally included in 1961 O+M					
manual. This pipe was retained under ABO No. 11499 (1975).					
FS Date: 1/9/2014

Concrete headwall visible on toe of WS berm.

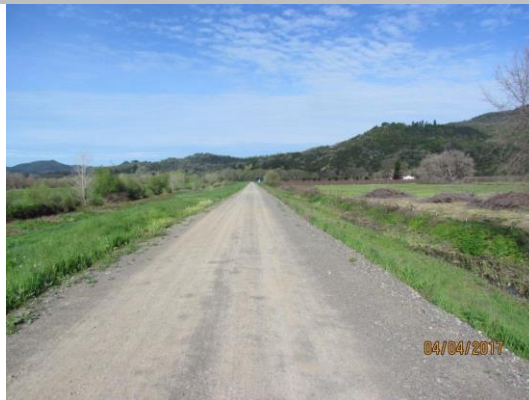
Photo 1 of 1 : SP_2017_NA0009_6_15_20170410_00021.jpg

LM Start	0.40	Rating **	A	Issue No.	15
LM End	0.40	Issue Type +	Ma	Location *	LS
Category	Earthen Levee			GPS Latitude/Longitude	
				Start	End
Item	Vegetation			39.176400 °	39.176400 °
				-122.905020 °	-122.905020 °
DWR ID	DWR_NA0009_04_s_2017_15				
Comment Code					
V1 : Control annual grass and weeds on the levee slopes and easements.					
Inspector Comment					
There are native grasses on both slopes.

View of the native grasses on both slopes.

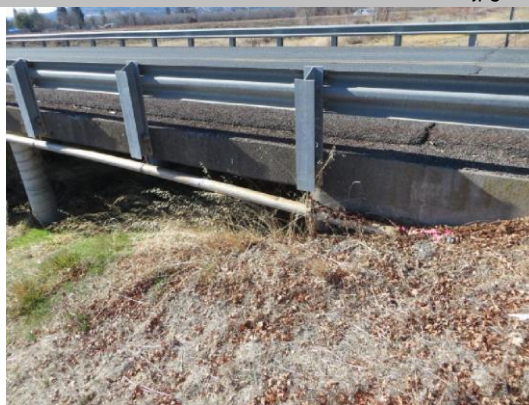
Photo 2 of 3 : UCIP_SP_2017_26907_49750.jpg

FS_ID:26907
DS_ID:21226
EP_NO: 6303
Repair Type: Non-Urgent
Crossing Status: Found
UCIP Comments: Pipe open on waterward side and should be plugged.
FIELD_STRUCT_DESC: 4-inch steel irrigation pipe through the levee, 1.5-feet below the crown. Steel cutoff wall around the pipe at center of levee. Pipe connects to 4-inch exposed aluminum pipe connected to upstream side of bridge (Permit No. 6303, -A, 1969).
FS Date: 1/9/2014

Pipe visible on upstream side of bridge.

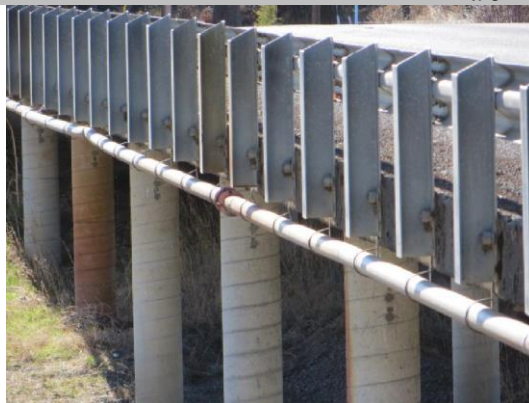
Photo 3 of 3 : UCIP_SP_2017_26907_49749.jpg

LM Start	0.53	Rating **	M	Issue No.	19 (cont)	
LM End	0.53	Issue Type +	En	Location *	LS	
Category	Supplemental			GPS Latitude/Longitude		
				Start	End	
Item	DWR UCIP Field Study			39.176410 °	39.176410 °	
				-122.902740 °	-122.902740 °	
DWR ID						
Comment Code						
Inspector Comment						
FS_ID:26907						
DS_ID:21226						
EP_NO: 6303						
Repair Type: Non-Urgent						
Crossing Status: Found						
UCIP Comments: Pipe open on waterwardside and should be plugged.						
FIELD_STRUCT_DESC: 4-inch steel irrigation pipe through the levee,						
1.5-feet below the crown. Steel cutoff wall around the pipe at center of						
levee. Pipe connects to 4-inch exposed aluminum pipe connected to						
upstream side of bridge (Permit No. 6303, -A, 1969).						
FS Date: 1/9/2014

Pipe visible on upstream side of bridge.

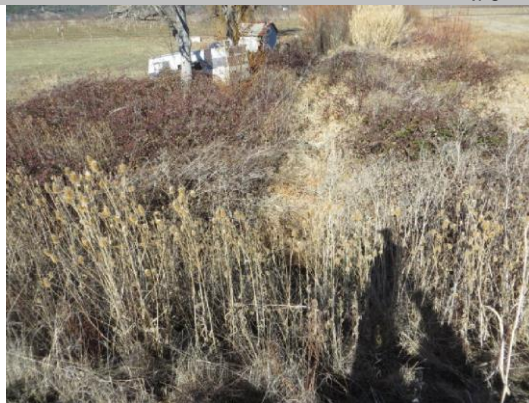
Photo 1 of 3 : UCIP_SP_2017_51472_49754.jpg

FS_ID:51472
DS_ID:21227
EP_NO: 11501
Repair Type: Urgent
Crossing Status: Found
UCIP Comments: 11/30/2016 Clover Creek has significant sediment build up that blocks the outlet. Crossing is still in use to drain water from LS to WS according to LMA representative, Scott Webb. (O. Magana - DWR UCIP)01/09/2014 Pipe rusted through at connection to flapgate. Good indication pipe may need replacement. Video inspection recommended. (W. Wylie - DWR UCIP)
FIELD_STRUCT_DESC: 24-inch corrugated metal (CM) drainage pipe through the levee, 13.8 feet below the crown. Flap gate is located on the waterside (WS) end. Concrete headwalls located on both the WS and landside (LS) ends. (24-inch pipe was retained under Automatic Board Order (ABO) issued as Permit No. 11501, 1975 - Sisevich).
[Additional Reference(s): DWR Levee Log, 2005. USACE Sacramento O&M Manual Unit 506.2, August 1961, (HLM 0.77)].
FS Date: 11/30/2016

Drainage canal at inlet on LS toe.

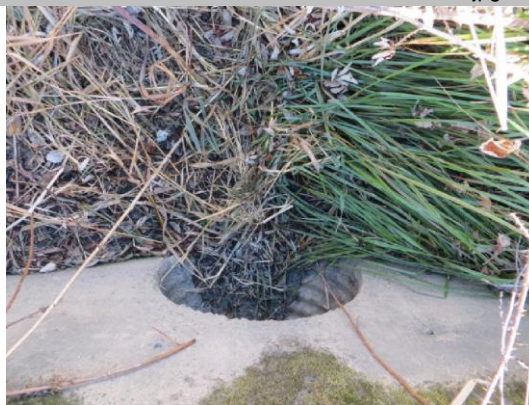
Photo 2 of 3 : UCIP_SP_2017_51472_49753.jpg

Pipe and concrete headwall visible in drainage channel on LS toe.

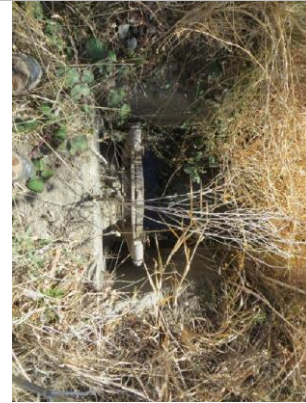
Photo 3 of 3 : UCIP_SP_2017_51472_49752.jpg

Comment Code					
Inspector Comment					
FS_ID:51472 DS_ID:21227 EP_NO: 11501 Repair Type: Urgent Crossing Status: Found UCIP Comments: 11/30/2016 Clover Creek has significant sediment build up that blocks the outlet. Crossing is still in use to drain water from LS to WS according to LMA representative, Scott Webb. (O. Magana - DWR UCIP)01/09/2014 Pipe rusted through at connection to flapgate. Good indication pipe may need replacement. Video inspection recommended. (W. Wylie - DWR UCIP) FIELD_STRUCT_DESC: 24-inch corrugated metal (CM) drainage pipe through the levee, 13.8 feet below the crown. Flap gate is located on the waterside (WS) end. Concrete headwalls located on both the WS and landside (LS) ends. (24-inch pipe was retained under Automatic Board Order (ABO) issued as Permit No. 11501, 1975 - Sisevich). [Additional Reference(s): DWR Levee Log, 2005. USACE Sacramento O&M Manual Unit 506.2, August 1961, (HLM 0.77)]. FS Date: 11/30/2016

Flapgate at concrete headwall on WS toe.

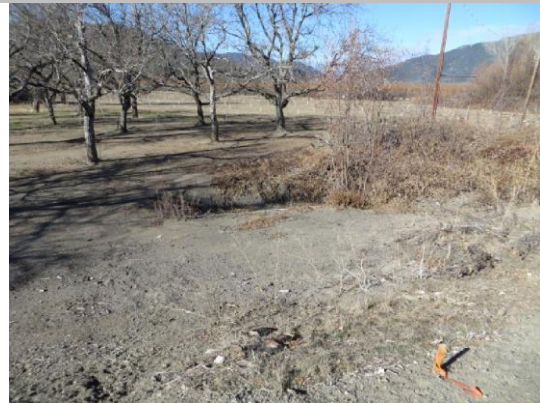
Photo 1 of 3 : UCIP_SP_2017_26924_49762.jpg

LM Start	1.19	Rating **	A/W	Issue No.	21
LM End	1.19	Issue Type +	Ma	Location *	LS
Category	Supplemental			GPS Latitude/Longitude	
				Start	End
Item	DWR UCIP LMA Responsibility			39.182079 °	39.182079 °
				-122.895038 °	-122.895038 °
DWR ID					
Comment Code					
Inspector Comment					
FS_ID:26924 DS_ID:21228 EP_NO: 11496 Repair Type: No Action Needed Crossing Status: Found UCIP Comments: FIELD_STRUCT_DESC: 42-inch CM drainpipe through the levee, 8- Feet below the crown. Flap gate on the waterward end. Concrete headwalls on both ends. Originally included in the 1961 O+M manual. This pipe was retained under ABO No. 11496 (1975). FS Date: 1/9/2014

Drainpipe visible at LS toe.

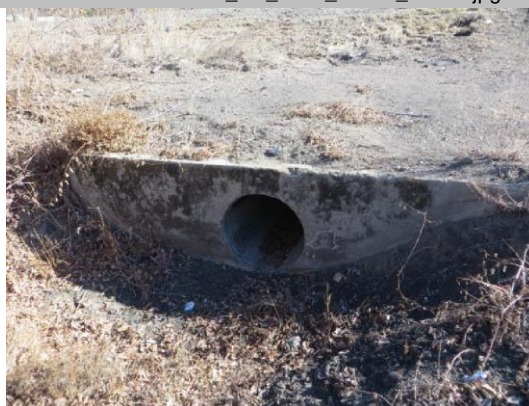
Photo 2 of 3 : UCIP_SP_2017_26924_49761.jpg

LM Start	1.19	Rating **	A/W	Issue No.	21 (cont)
LM End	1.19	Issue Type +	Ma	Location *	LS
Category	Supplemental			GPS Latitude/Longitude	
				Start	End
Item	DWR UCIP LMA Responsibility			39.182079 °	39.182079 °
				-122.895038 °	-122.895038 °
DWR ID					
Comment Code					
Inspector Comment					
FS_ID:26924					
DS_ID:21228					
EP_NO: 11496					
Repair Type: No Action Needed					
Crossing Status: Found					
UCIP Comments:					
FIELD_STRUCT_DESC: 42-inch CM drainpipe through the levee, 8-					
Feet below the crown. Flap gate on the waterward end. Concrete					
headwalls on both ends. Originally included in the 1961 O+M manual.					
This pipe was retained under ABO No. 11496 (1975).					
FS Date: 1/9/2014

Concrete headwall and drainpipe visible at LS toe.

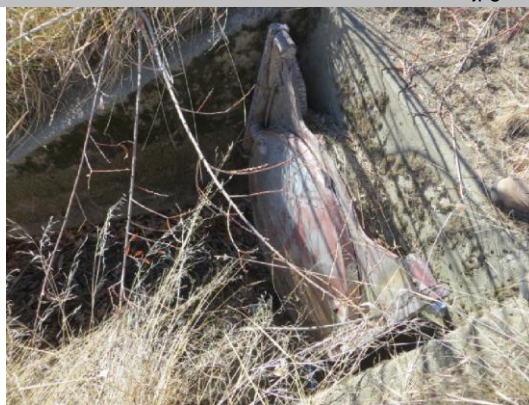
Photo 3 of 3 : UCIP_SP_2017_26924_49760.jpg

LM Start	1.19	Rating **	A/W	Issue No.	21 (cont)
LM End	1.19	Issue Type +	Ma	Location *	LS

Concrete headwall visible off WS berm.

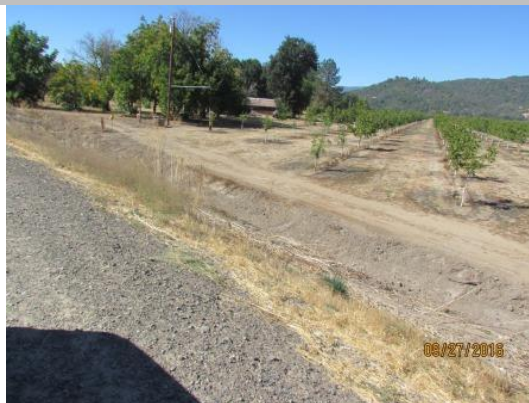
Photo 1 of 1 : SP_2017_NA0009_6_13_20170315_00005.jpg

LM Start	1.19	Rating **	M	Issue No.	13
LM End	1.25	Issue Type +	En	Location *	LS
Category	Earthen Levee			GPS Latitude/Longitude	
				Start	End
Item	Encroachments			39.182161 °	39.182862 °
				-122.894983 °	-122.894505 °
DWR ID	DWR_NA0009_04_f_2016_13				
Comment Code					
DT : Ditch					
Inspector Comment

View of a ditch at the landside toe looking downstream.

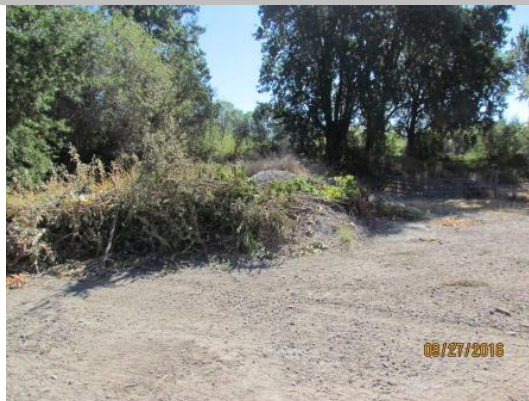
Photo 1 of 1 : SP_2017_NA0009_6_10_20170315_00004.jpg

LM Start	1.42	Rating **	M	Issue No.	10
LM End	1.42	Issue Type +	En	Location *	WS
Category	Earthen Levee			GPS Latitude/Longitude	
				Start	End
Item	Encroachments			39.185074 °	39.185074 °
				-122.893382 °	-122.893382 °
DWR ID	DWR_NA0009_04_f_2016_10				
Comment Code					
DE : Debris					
Inspector Comment

View of the prunings and soil pile on the waterside berm looking downstream.

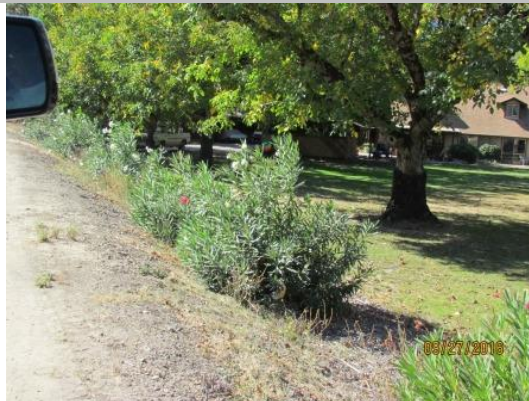
Photo 1 of 1 : SP_2017_NA0009_6_4_20170315_00002.jpg

LM Start	1.43	Rating **	M	Issue No.	4
LM End	1.46	Issue Type +	En	Location *	LS
Category	Earthen Levee			GPS Latitude/Longitude	
				Start	End
Item	Vegetation			39.185183 °	39.185568 °
				-122.893384 °	-122.893348 °
DWR ID	DWR_NA0009_04_f_2016_4				
Comment Code					
V6 : Landscaping					
Inspector Comment					
Oleanders blocking visibility.

View of the Oleanders looking downstream.

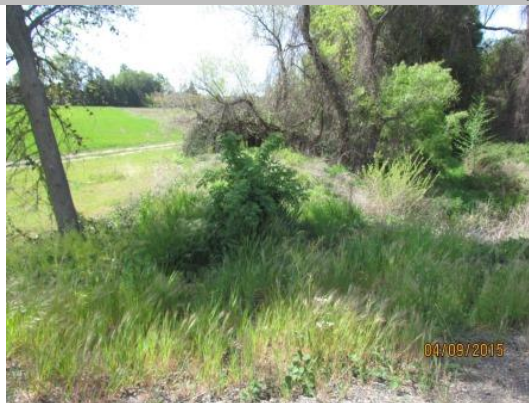
Photo 1 of 1 : SP_2017_NA0009_7_3_20170315_00001.jpg

LM Start	0.30	Rating **	M	Issue No.	3
LM End	0.30	Issue Type +	Ma	Location *	LS
Category	Earthen Levee			GPS Latitude/Longitude	
				Start	End
Item	Vegetation			39.176957 °	39.176957 °
				-122.898673 °	-122.898673 °
DWR ID	DWR_NA0009_05_s_2012_3				
Comment Code					
V4 : Elderberries are blocking visibility and flood fight capability.					
Inspector Comment

View of the elderberry along the landside toe.

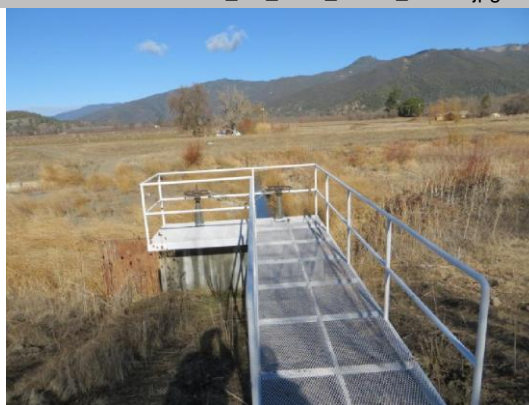
Photo 1 of 3 : UCIP_SP_2017_26897_49712.jpg

LM Start	0.31	Rating **	M	Issue No.	14
LM End	0.31	Issue Type +	Ma	Location *	LS
Category	Supplemental			GPS Latitude/Longitude	
				Start	End
Item	DWR UCIP LMA Responsibility			39.177076 °	39.177076 °
				-122.898879 °	-122.898879 °
DWR ID					
Comment Code					
Inspector Comment					
FS_ID:26897					
DS_ID:21235					
EP_NO: 11507					
Repair Type: Non-Urgent					
Crossing Status: Found					
UCIP Comments: Some sediment buildup at LS toe.					
FIELD_STRUCT_DESC: 1 of 6: 36-inch CM irrigation pipe through the					
levee, 12.0 feet below the crown. Slide gate on waterward end. Steel					
walkway on waterward slope to slide gate. Concrete headwall on both					
ends. Originally included in 1961 O+M manual. Structure and pipes					
retained under ABO Permit No. 11507 (1975).					
FS Date: 1/9/2014

Slide gate at steel walkway on WS toe.

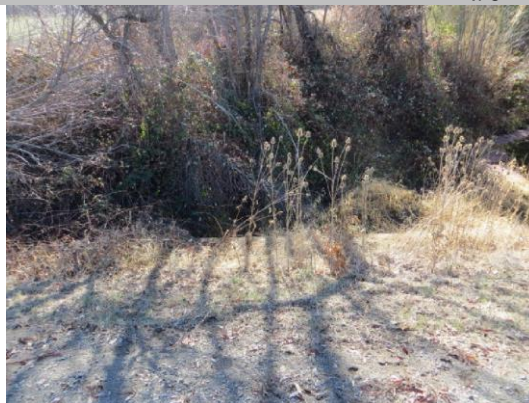
Photo 2 of 3 : UCIP_SP_2017_26897_49711.jpg

LM Start	0.31	Rating **	M	Issue No.	14 (cont)
LM End	0.31	Issue Type +	Ma	Location *	LS
Category	Supplemental			GPS Latitude/Longitude	
				Start	End
Item	DWR UCIP LMA Responsibility			39.177076 °	39.177076 °
				-122.898879 °	-122.898879 °
DWR ID					
Comment Code					
Inspector Comment					
FS_ID:26897					
DS_ID:21235					
EP_NO: 11507					
Repair Type: Non-Urgent					
Crossing Status: Found					
UCIP Comments: Some sediment buildup at LS toe.					
FIELD_STRUCT_DESC: 1 of 6: 36-inch CM irrigation pipe through the levee, 12.0 feet below the crown. Slide gate on waterward end. Steel walkway on waterward slope to slide gate. Concrete headwall on both ends. Originally included in 1961 O+M manual. Structure and pipes retained under ABO Permit No. 11507 (1975).					
FS Date: 1/9/2014

Outlet visible at concrete headwall on LS toe.

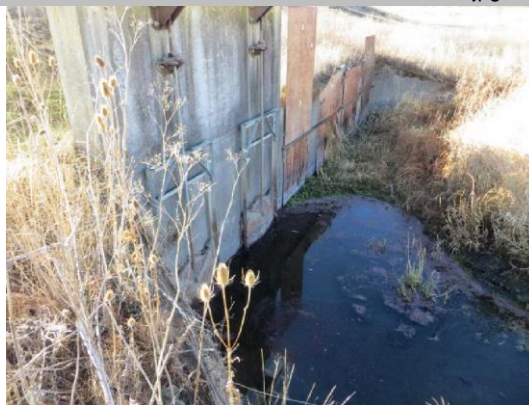
Photo 3 of 3 : UCIP_SP_2017_26897_49710.jpg

LM Start	0.31	Rating **	M	Issue No.	14 (cont)
LM End	0.31	Issue Type +	Ma	Location *	LS

Slide gate at concrete headwall on WS toe.

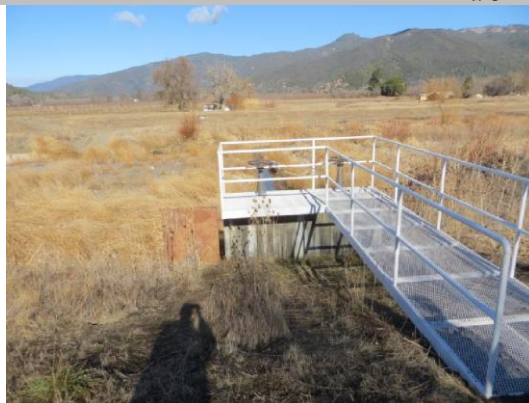
Photo 1 of 3 : UCIP_SP_2017_26891_49682.jpg

LM Start	0.31	Rating **	M	Issue No.	15
LM End	0.31	Issue Type +	Ma	Location *	LS
Category	Supplemental			GPS Latitude/Longitude	
				Start	End
Item	DWR UCIP LMA Responsibility			39.177074 °	39.177074 °
				-122.898902 °	-122.898902 °
DWR ID					
Comment Code					
Inspector Comment					
FS_ID:26891					
DS_ID:21234					
EP_NO: 11507					
Repair Type: Non-Urgent					
Crossing Status: Found					
UCIP Comments: Some sediment buildup on LS toe.					
FIELD_STRUCT_DESC: 2 of 6: 36-inch CM irrigation pipe through the					
levee, 12.0 feet below the crown. Slide gate on waterward end. Steel					
walkway on waterward slope to slide gate. Concrete headwalls on both					
ends. Originally included in 1961 O+M manual. Structure and pipes					
retained under ABO Permit No. 11507 (1975).					
FS Date: 1/9/2014

Slide gate on steel walkway at WS toe.

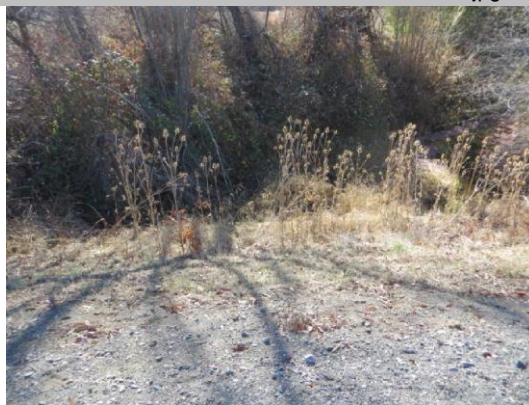
Photo 2 of 3 : UCIP_SP_2017_26891_49681.jpg

Outlet visible at concrete headwall on LS toe.

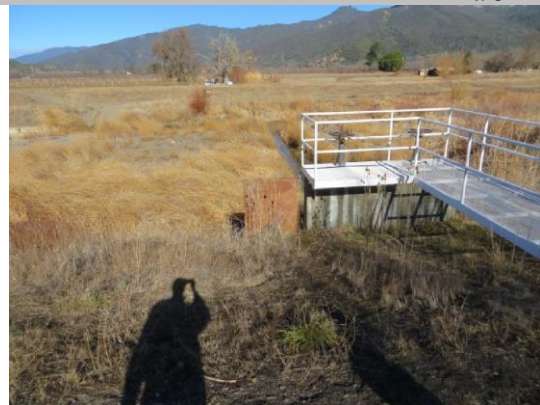
Photo 1 of 3 : UCIP_SP_2017_26888_49666.jpg

LM Start	0.32	Rating **	M	Issue No.	16
LM End	0.32	Issue Type +	Ma	Location *	LS
Category	Supplemental			GPS Latitude/Longitude	
				Start	End
Item	DWR UCIP LMA Responsibility			39.177078 °	39.177078 °
				-122.898926 °	-122.898926 °
DWR ID					
Comment Code					
Inspector Comment					
FS_ID:26888 DS_ID:21233 EP_NO: 11507 Repair Type: Non-Urgent Crossing Status: Found UCIP Comments: Some sediment buildup at outlet on LS toe. FIELD_STRUCT_DESC: 3 of 6: 36-inch CM irrigation pipe through the levee, 12.0 feet below the crown. Concrete headwall on both ends. Steel slide gate plate blocks inlet on WS toe. Originally included in 1961 O+M manual. Structure and pipes retained under ABO Permit No. 11507 (1975). FS Date: 1/9/2014

Steel slide gate visible at concrete headwall on WS toe.

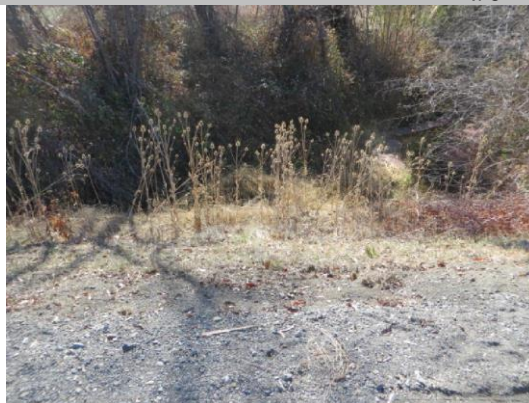
Photo 2 of 3 : UCIP_SP_2017_26888_49665.jpg

LM Start	0.32	Rating **	M	Issue No.	16 (cont)
LM End	0.32	Issue Type +	Ma	Location *	LS

Outlet visible at concrete headwall on LS toe.

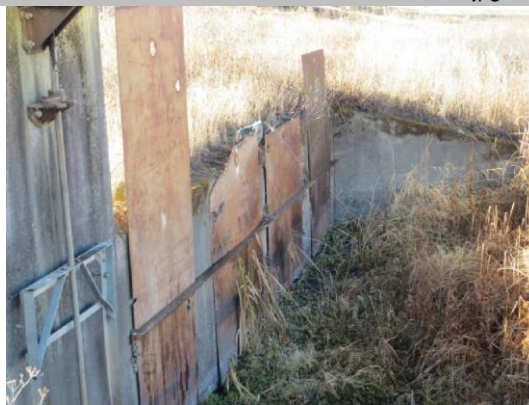
Photo 3 of 3 : UCIP_SP_2017_26888_49664.jpg

Steel slide gate visible at concrete headwall on WS toe.

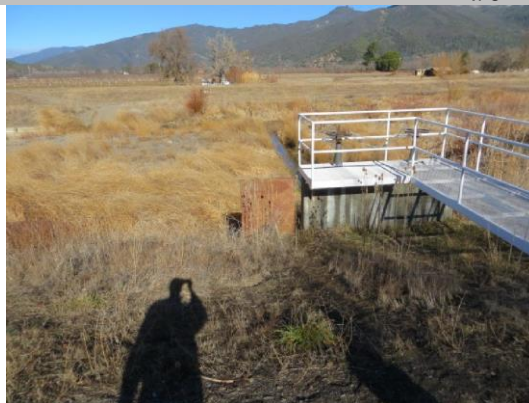
Photo 1 of 3 : UCIP_SP_2017_26885_49634.jpg

LM Start	0.32	Rating **	M	Issue No.	17
LM End	0.32	Issue Type +	Ma	Location *	LS
Category	Supplemental			GPS Latitude/Longitude	
				Start	End
Item	DWR UCIP LMA Responsibility			39.177074 °	39.177074 °
				-122.898949 °	-122.898949 °
DWR ID					
Comment Code					
Inspector Comment					
FS_ID:26885					
DS_ID:21232					
EP_NO: 11507					
Repair Type: Non-Urgent					
Crossing Status: Found					
UCIP Comments: Some sediment buildup at outlet on LS toe.					
FIELD_STRUCT_DESC: 4 of 6: 36-inch CM irrigation pipe through the					
levee, 12.0 feet below the crown. Concrete headwall on both ends					
[Clover Creek Diversion Structure] . Originally included in 1961 O+M					
manual. Structure and pipes retained under ABO Permit No. 11507					
(1975).					
FS Date: 1/9/2014

Steel plate slide gate visible at headwall on WS toe.

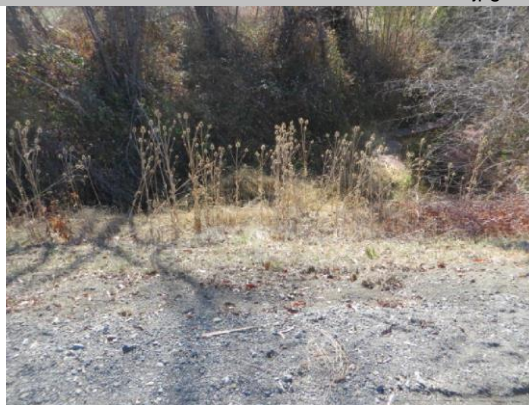
Photo 2 of 3 : UCIP_SP_2017_26885_49633.jpg

Outlet visible at concrete headwall on LS toe.

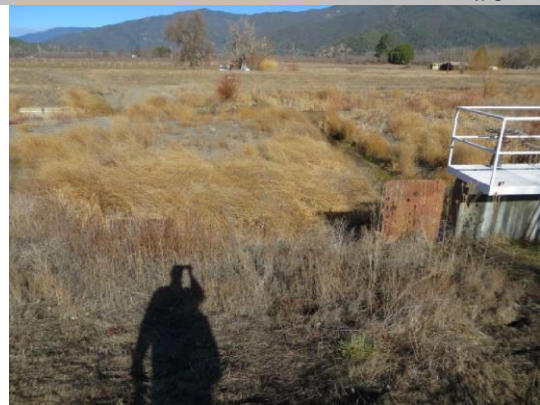
Photo 1 of 3 : UCIP_SP_2017_26883_49622.jpg

LM Start	0.32	Rating **	M	Issue No.	18
LM End	0.32	Issue Type +	Ma	Location *	LS
Category	Supplemental			GPS Latitude/Longitude	
				Start	End
Item	DWR UCIP LMA Responsibility			39.177070 °	39.177070 °
				-122.898967 °	-122.898967 °
DWR ID					
Comment Code					
Inspector Comment					
FS_ID:26883 DS_ID:21231 EP_NO: 11507 Repair Type: Non-Urgent Crossing Status: Found UCIP Comments: Some sediment buildup on LS toe. FIELD_STRUCT_DESC: 5 of 6: 36-inch CM irrigation pipe through the levee, 12.0 feet below the crown. Concrete headwall on both ends [Clover Creek Diversion Structure] . Steel slide gate blocks inlet on WS toe. Originally included in 1961 O+M manual. Structure and pipes retained under ABO Permit No. 11507 (1975). FS Date: 1/9/2014

Metal slide gate visible at concrete headwall on WS toe.

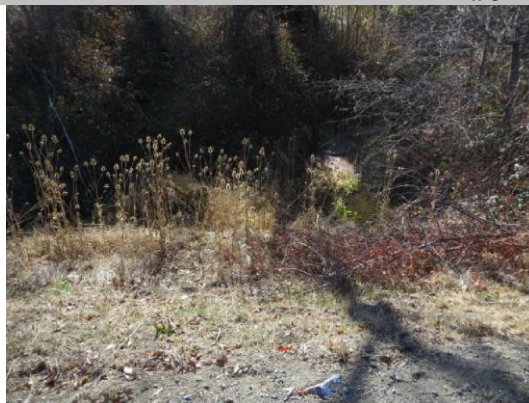
Photo 2 of 3 : UCIP_SP_2017_26883_49621.jpg

LM Start	0.32	Rating **	M	Issue No.	18 (cont)
LM End	0.32	Issue Type +	Ma	Location *	LS
Category	Supplemental			GPS Latitude/Longitude	
				Start	End
Item	DWR UCIP LMA Responsibility			39.177070 °	39.177070 °
				-122.898967 °	-122.898967 °
DWR ID					
Comment Code					
Inspector Comment					
FS_ID:26883					
DS_ID:21231					
EP_NO: 11507					
Repair Type: Non-Urgent					
Crossing Status: Found					
UCIP Comments: Some sediment buildup on LS toe.					
FIELD_STRUCT_DESC: 5 of 6: 36-inch CM irrigation pipe through the					
levee, 12.0 feet below the crown. Concrete headwall on both ends					
[Clover Creek Diversion Structure] . Steel slide gate blocks inlet on WS					
toe. Originally included in 1961 O+M manual. Structure and pipes					
retained under ABO Permit No. 11507 (1975).					
FS Date: 1/9/2014

Pipe visible at concrete headwall on LS toe.

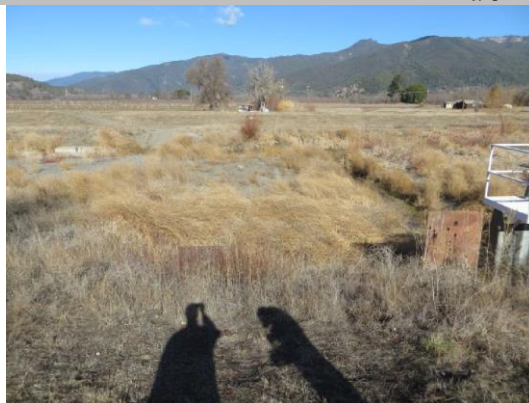
Photo 1 of 3 : UCIP_SP_2017_26877_49610.jpg

LM Start	0.32	Rating **	M	Issue No.	19
LM End	0.32	Issue Type +	Ma	Location *	LS
Category	Supplemental			GPS Latitude/Longitude	
				Start	End
Item	DWR UCIP LMA Responsibility			39.177066 °	39.177066 °
				-122.898986 °	-122.898986 °
DWR ID					
Comment Code					
Inspector Comment					
FS_ID:26877					
DS_ID:21229					
EP_NO: 11507					
Repair Type: Non-Urgent					
Crossing Status: Found					
UCIP Comments: Some sediment buildup at outlet on LS toe.					
FIELD_STRUCT_DESC: 6 of 6: 36-inch CM pipe through the levee,					
12.0 feet below the crown [Clover Creek Diversion Structure]. Concrete					
headwall on both ends. Steel slide gate covers WS inlet. Structure and					
pipes retained under ABO Permit No. 11507 (1975). Originally included					
in 1961 O+M manual.					
FS Date: 1/9/2014

Steel slide gate visible at headwall on WS toe.

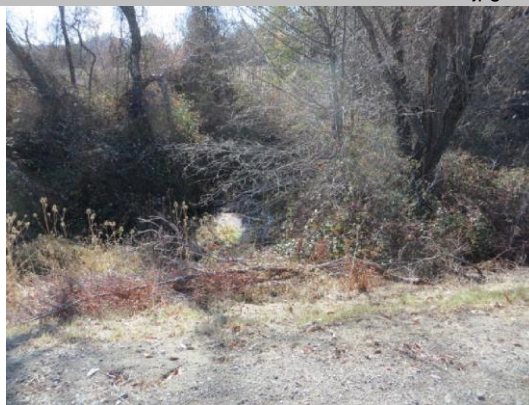
Photo 2 of 3 : UCIP_SP_2017_26877_49609.jpg

Concrete headwall on LS toe.

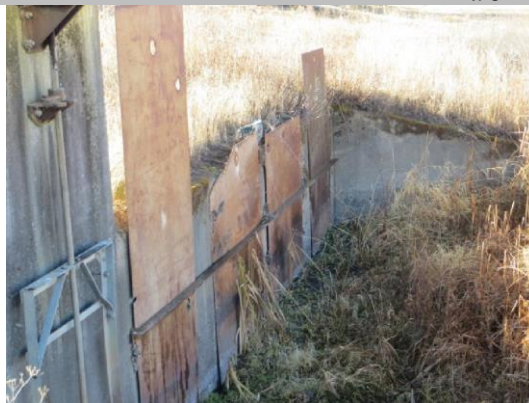
Photo 3 of 3 : UCIP_SP_2017_26877_49608.jpg

LM Start	0.32	Rating **	M	Issue No.	19 (cont)
LM End	0.32	Issue Type +	Ma	Location *	LS
Category	Supplemental			GPS Latitude/Longitude	
				Start	End
Item	DWR UCIP LMA Responsibility			39.177066 °	39.177066 °
				-122.898986 °	-122.898986 °
DWR ID					
Comment Code					
Inspector Comment					
FS_ID:26877					
DS_ID:21229					
EP_NO: 11507					
Repair Type: Non-Urgent					
Crossing Status: Found					
UCIP Comments: Some sediment buildup at outlet on LS toe.					
FIELD_STRUCT_DESC: 6 of 6: 36-inch CM pipe through the levee,					
12.0 feet below the crown [Clover Creek Diversion Structure]. Concrete					
headwall on both ends. Steel slide gate covers WS inlet. Structure and					
pipes retained under ABO Permit No. 11507 (1975). Originally included					
in 1961 O+M manual.					
FS Date: 1/9/2014

Steel slide gate visible at headwall on WS toe.

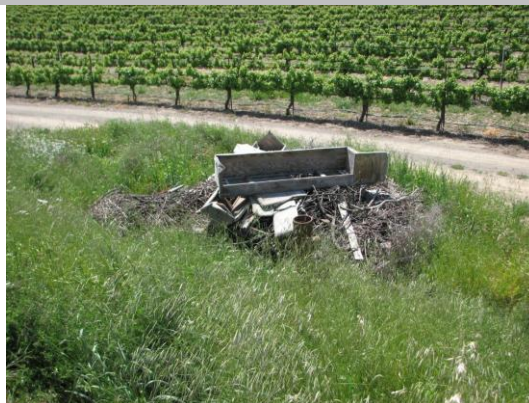
Photo 1 of 1 : SP_2017_NA0009_7_10_20170315_00003.jpg

LM Start	0.63	Rating **	M	Issue No.	10
LM End	0.63	Issue Type +	En	Location *	LS
Category	Earthen Levee			GPS Latitude/Longitude	
				Start	End
Item	Encroachments			39.175758 °	39.175758 °
				-122.904353 °	-122.904353 °
DWR ID	DWR_NA0009_05_s_2016_10				
Comment Code					
DE : Debris					
Inspector Comment					
Remove prunings and wooden lumber debris.

5/2/2016: Remove prunings and lumber debris from L/S toe.

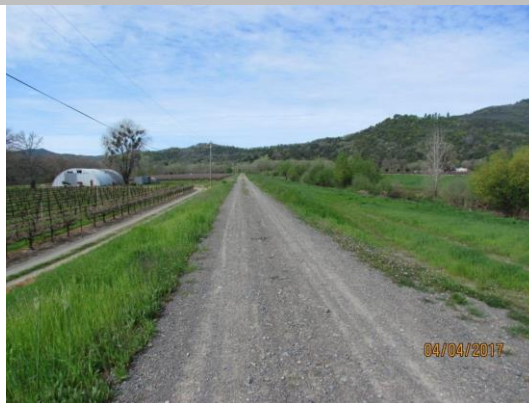
Photo 1 of 1 : SP_2017_NA0009_7_13_20170410_00023.jpg

LM Start	0.68	Rating **	A	Issue No.	13
LM End	0.68	Issue Type +	Ma	Location *	LS
Category	Earthen Levee			GPS Latitude/Longitude	
				Start	End
Item	Vegetation			39.175715 °	39.175715 °
				-122.905222 °	-122.905222 °
DWR ID	DWR_NA0009_05_s_2017_13				
Comment Code					
V1 : Control annual grass and weeds on the levee slopes and easements.					
Inspector Comment					
There are native grasses on both slopes.

View of the native grasses on both slopes.

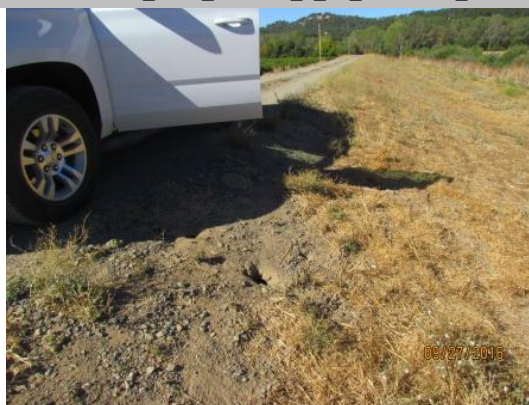
Photo 1 of 1 : SP_2017_NA0009_7_11_20170315_00004.jpg

LM Start	0.90	Rating **	M	Issue No.	11
LM End	0.90	Issue Type +	Ma	Location *	WS
Category	Earthen Levee			GPS Latitude/Longitude	
				Start	End
Item	Animal Control			39.175779 °	39.175779 °
				-122.909325 °	-122.909325 °
DWR ID	DWR_NA0009_05_f_2016_11				
Comment Code					
A1 : Exterminate rodents and backfill and compact or grout burrows.					
Inspector Comment

View of the rodent holes along the landside slope.

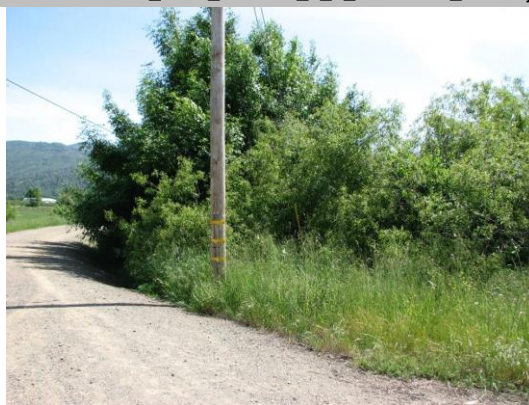
Photo 1 of 1 : SP_2017_NA0009_7_4_20170315_00002.jpg

LM Start	1.02	Rating **	M	Issue No.	4
LM End	1.02	Issue Type +	Ma	Location *	LS
Category	Earthen Levee			GPS Latitude/Longitude	
				Start	End
Item	Trim / Thin Trees			39.175718 °	39.175718 °
				-122.911618 °	-122.911618 °
DWR ID	DWR_NA0009_05_f_2016_4				
Comment Code					
T2 : Thin trees to allow visibility of the ground and room to flood fight.					
Inspector Comment

Trim/remove trees to allow visibility along landside slope.
